THE MUNICIPALITY OF THE VILLAGE OF LIONS BAY

Tree Cutting Application Form

Arborist Report

[REDACTED]
220 Isleview Place

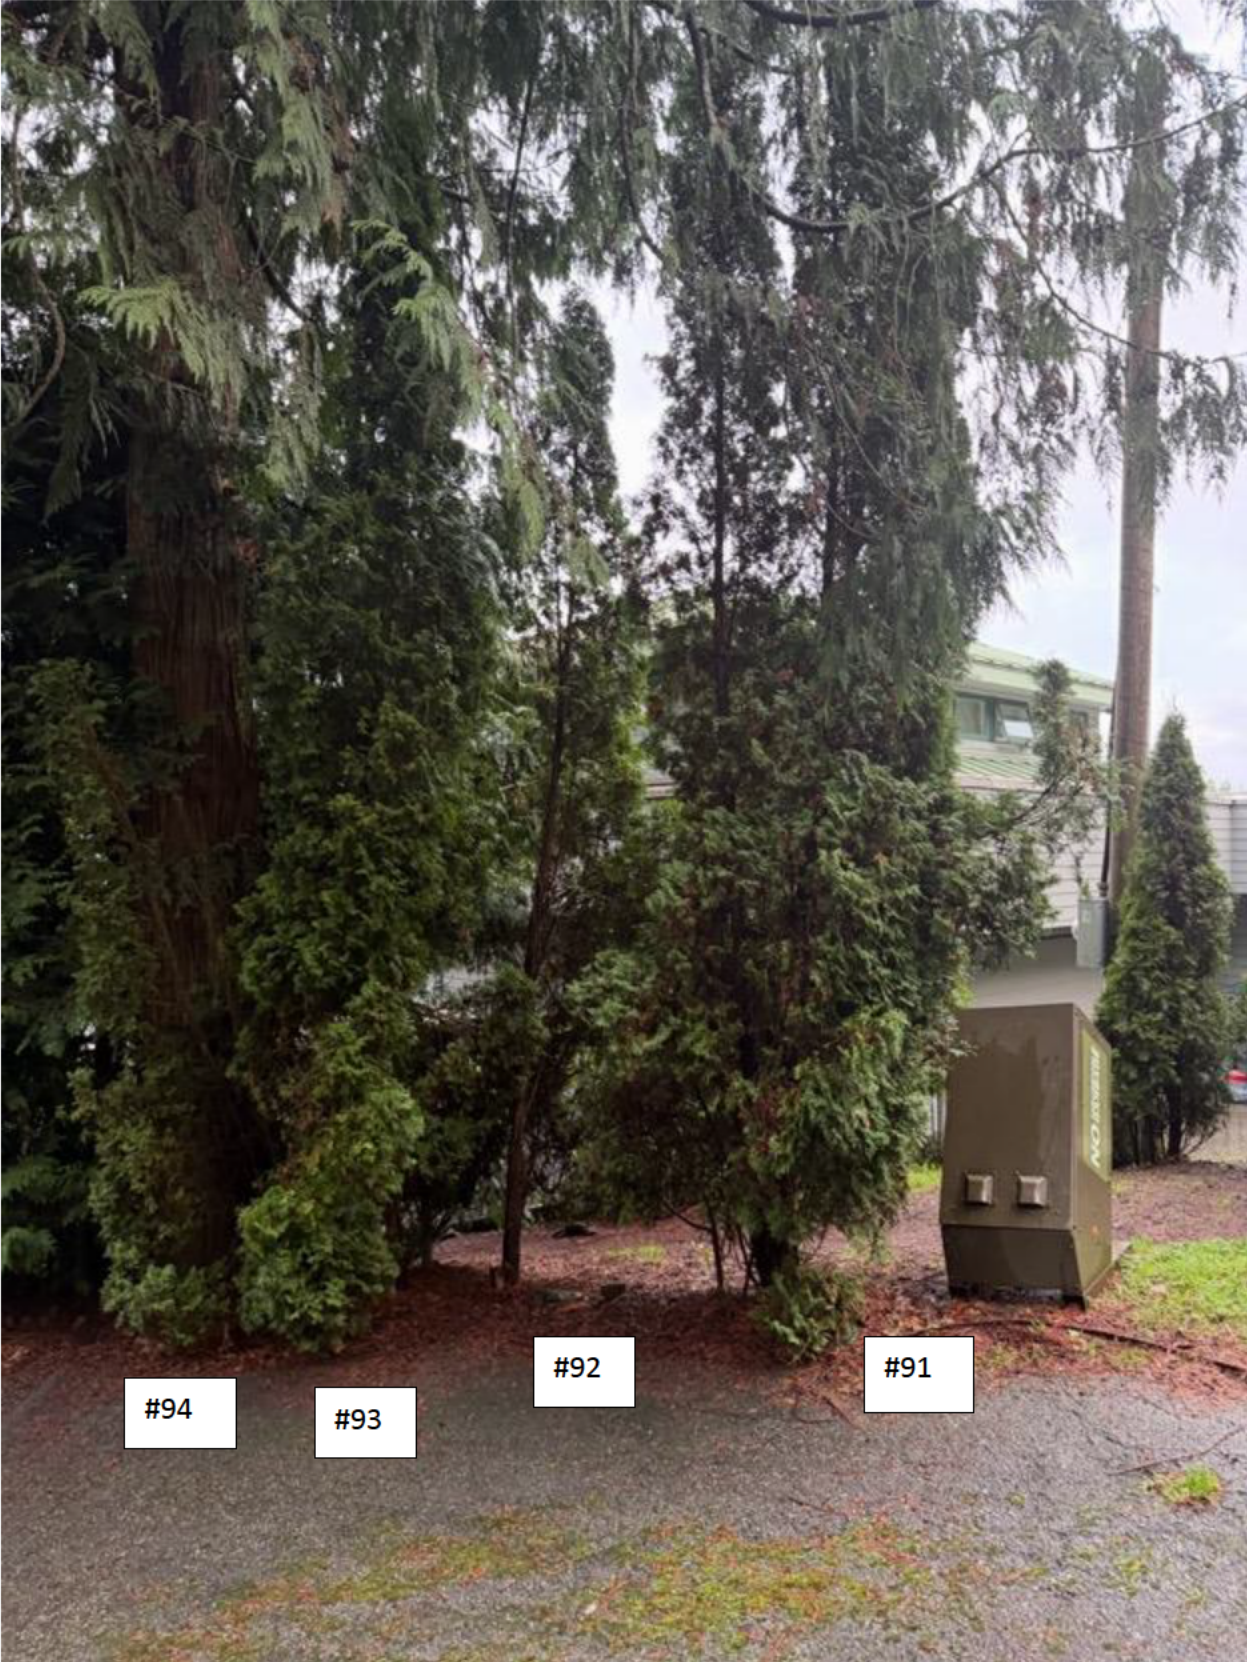
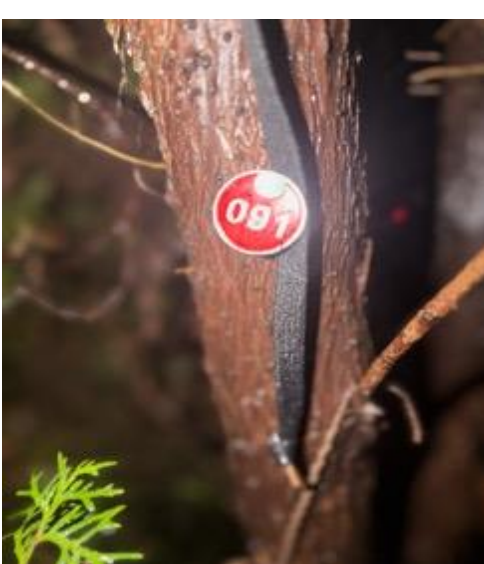
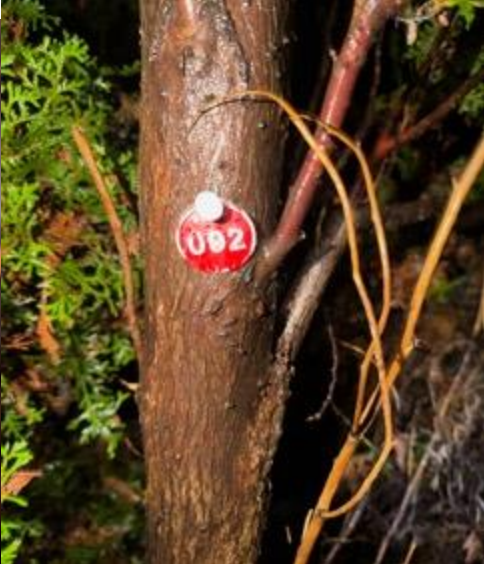
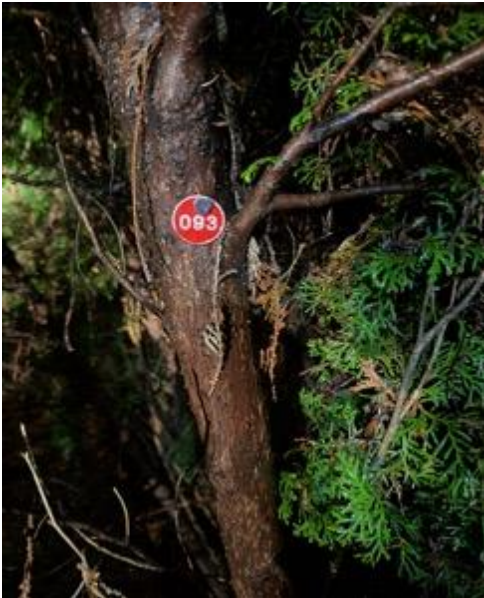
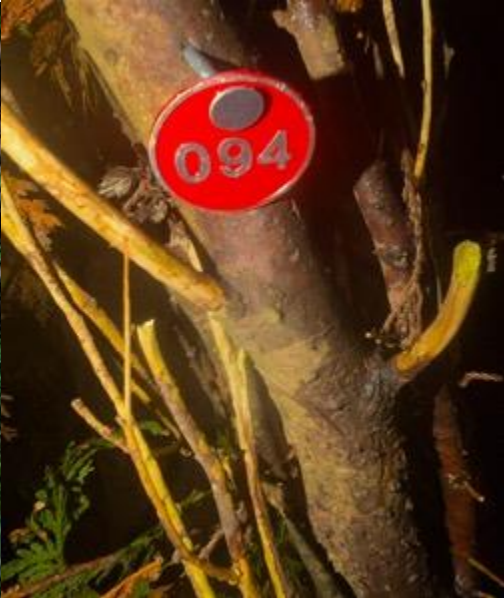
A level 1 inspection was carried out on four Emerald hedging cedars and seven Western red cedar trees

#91, #92, #93, #94,

Emerald cedar (*Thuja occidentalis* 'smaragd;)

DBH 16 cm, 10 cm, 10 cm, 12 cm

Height. 4 m

These Emerald cedars have a diameter of less than 20 cm and are in poor condition with signs of dieback with and are structurally defective. In order for the equipment to access the site, these trees will need to be removed.

After construction is complete it is recommended to grind the stumps of the trees to be removed and plant 11 Western red cedar trees from 2-3 meters in height with a 6 cm caliper. To regrow a barrier wall from the property to the pathway.

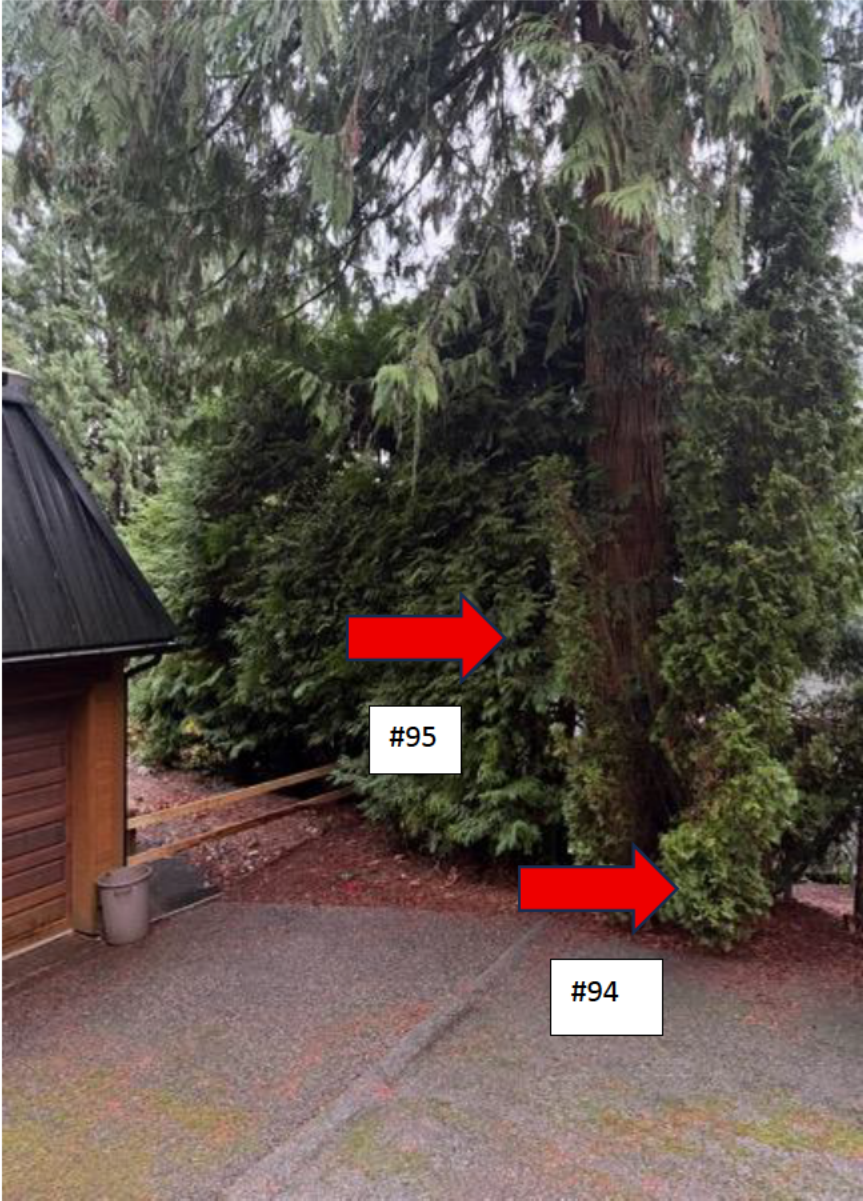
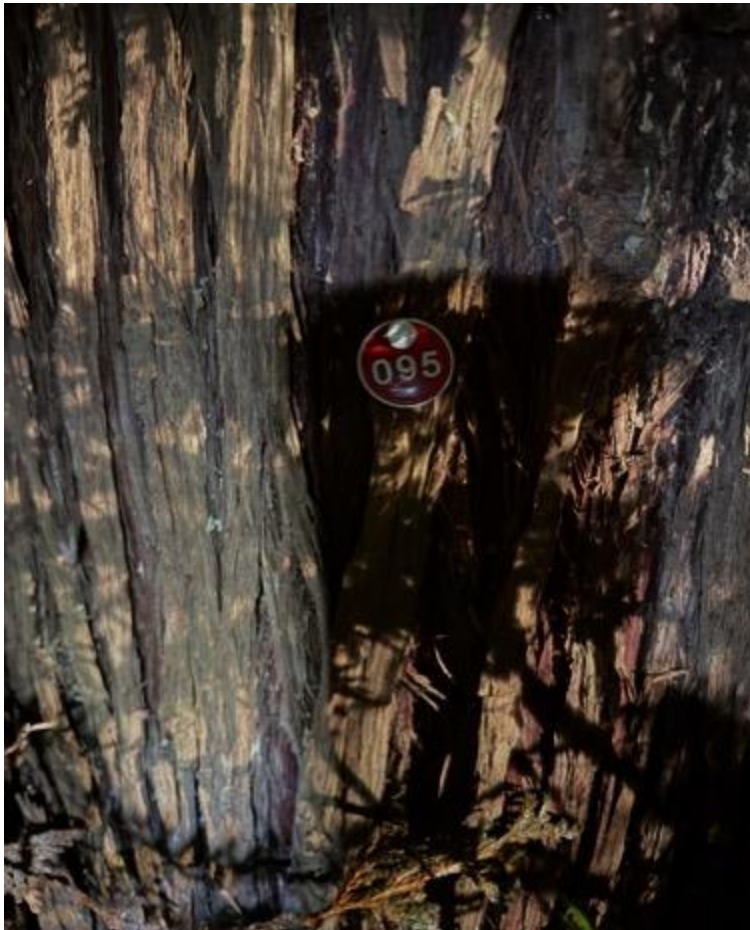
#95

Western red cedar (*Thuja plicata*)

DBH 79 cm

Height. 23 meters

Crown Spread 6 meters

This Western red cedar tree is in fair to good condition. In order for the equipment to access the site, this tree will need to be removed

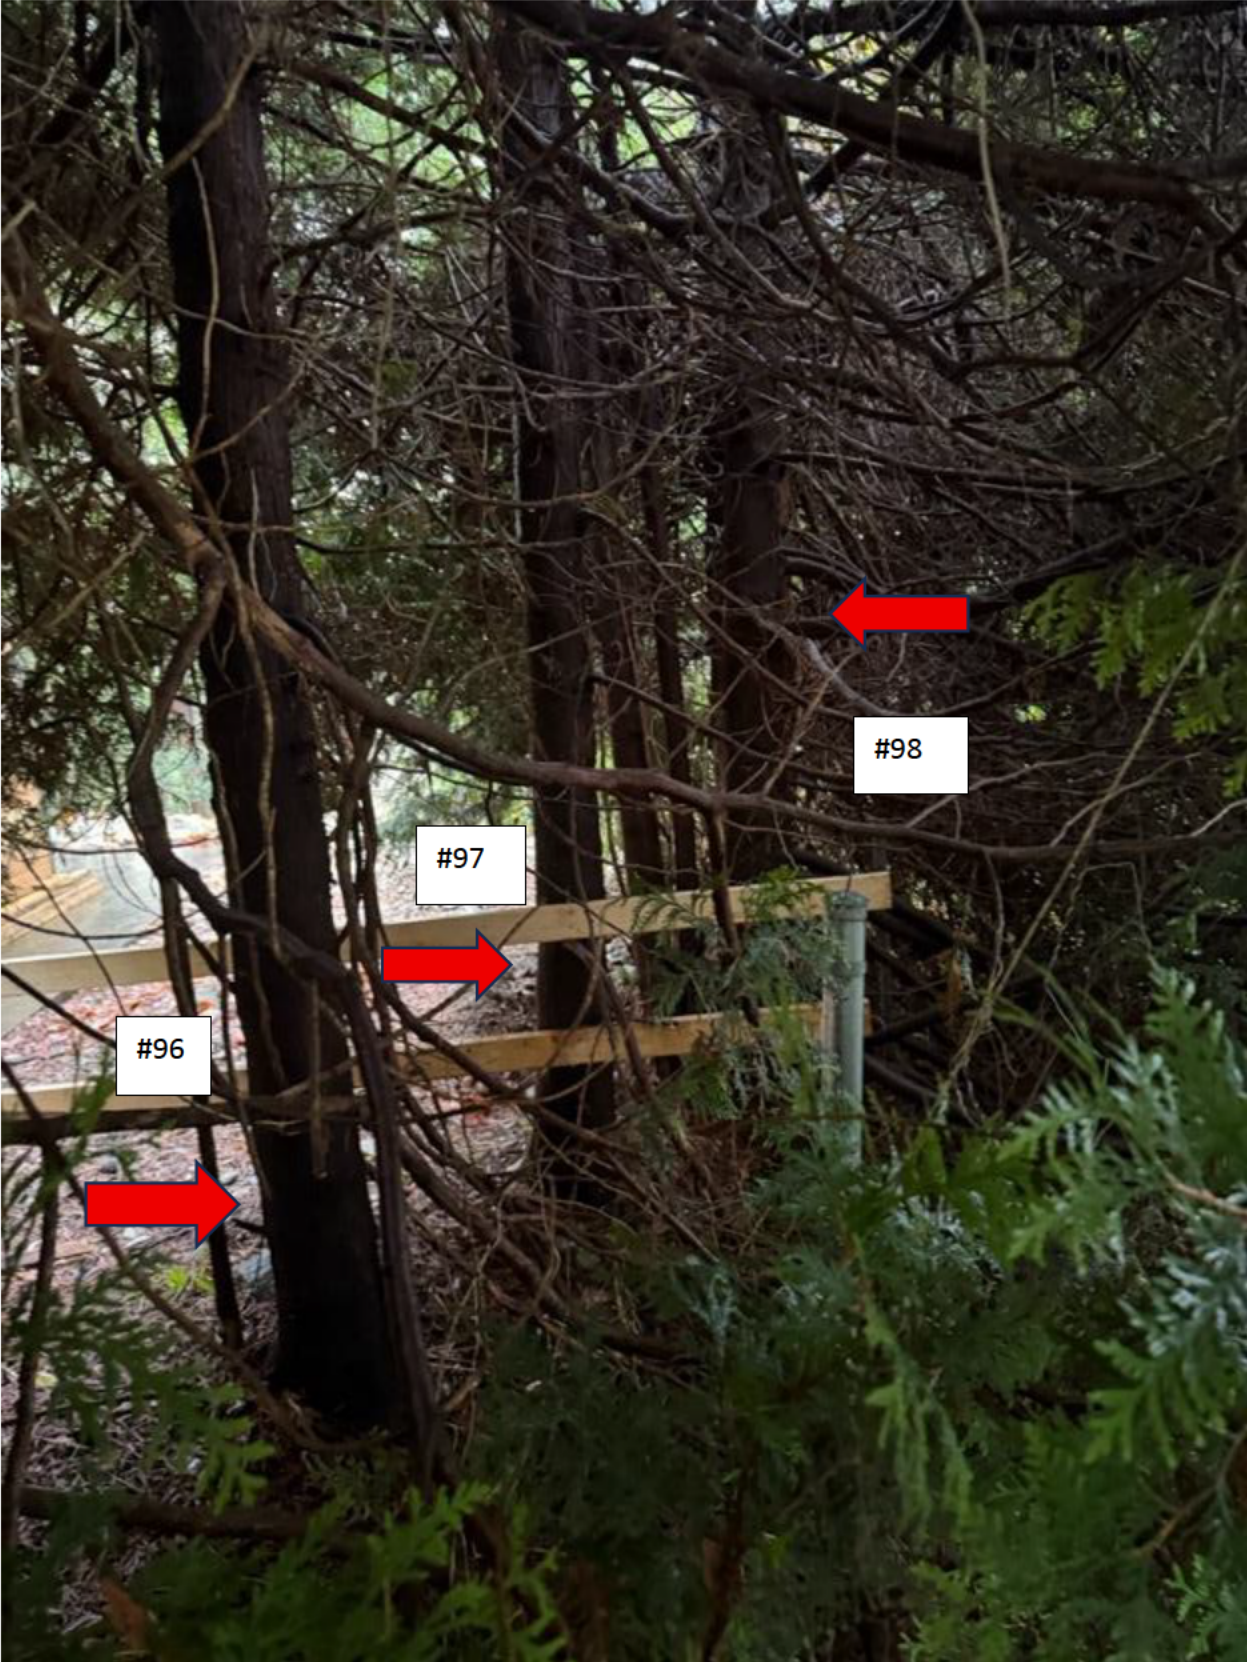
This Western red cedar was previously topped, with multi-stems and the foliage sheared. Condition is poor with 50% dieback. This tree is less dominant with limited access to sunlight. In order for the equipment to access the site, this tree will need to be removed

This Western red cedar was previously topped and the foliage sheared with a diameter of less than 20 cm. Condition is poor with 50% dieback. This tree is less dominant with limited access to sunlight. In order for the equipment to access the site, this tree will need to be removed
