THE MUNICIPALITY OF THE VILLAGE OF LIONS BAY

Tree Cutting Application Form

Arborist Report

[REDACTED]
220 Isleview Place

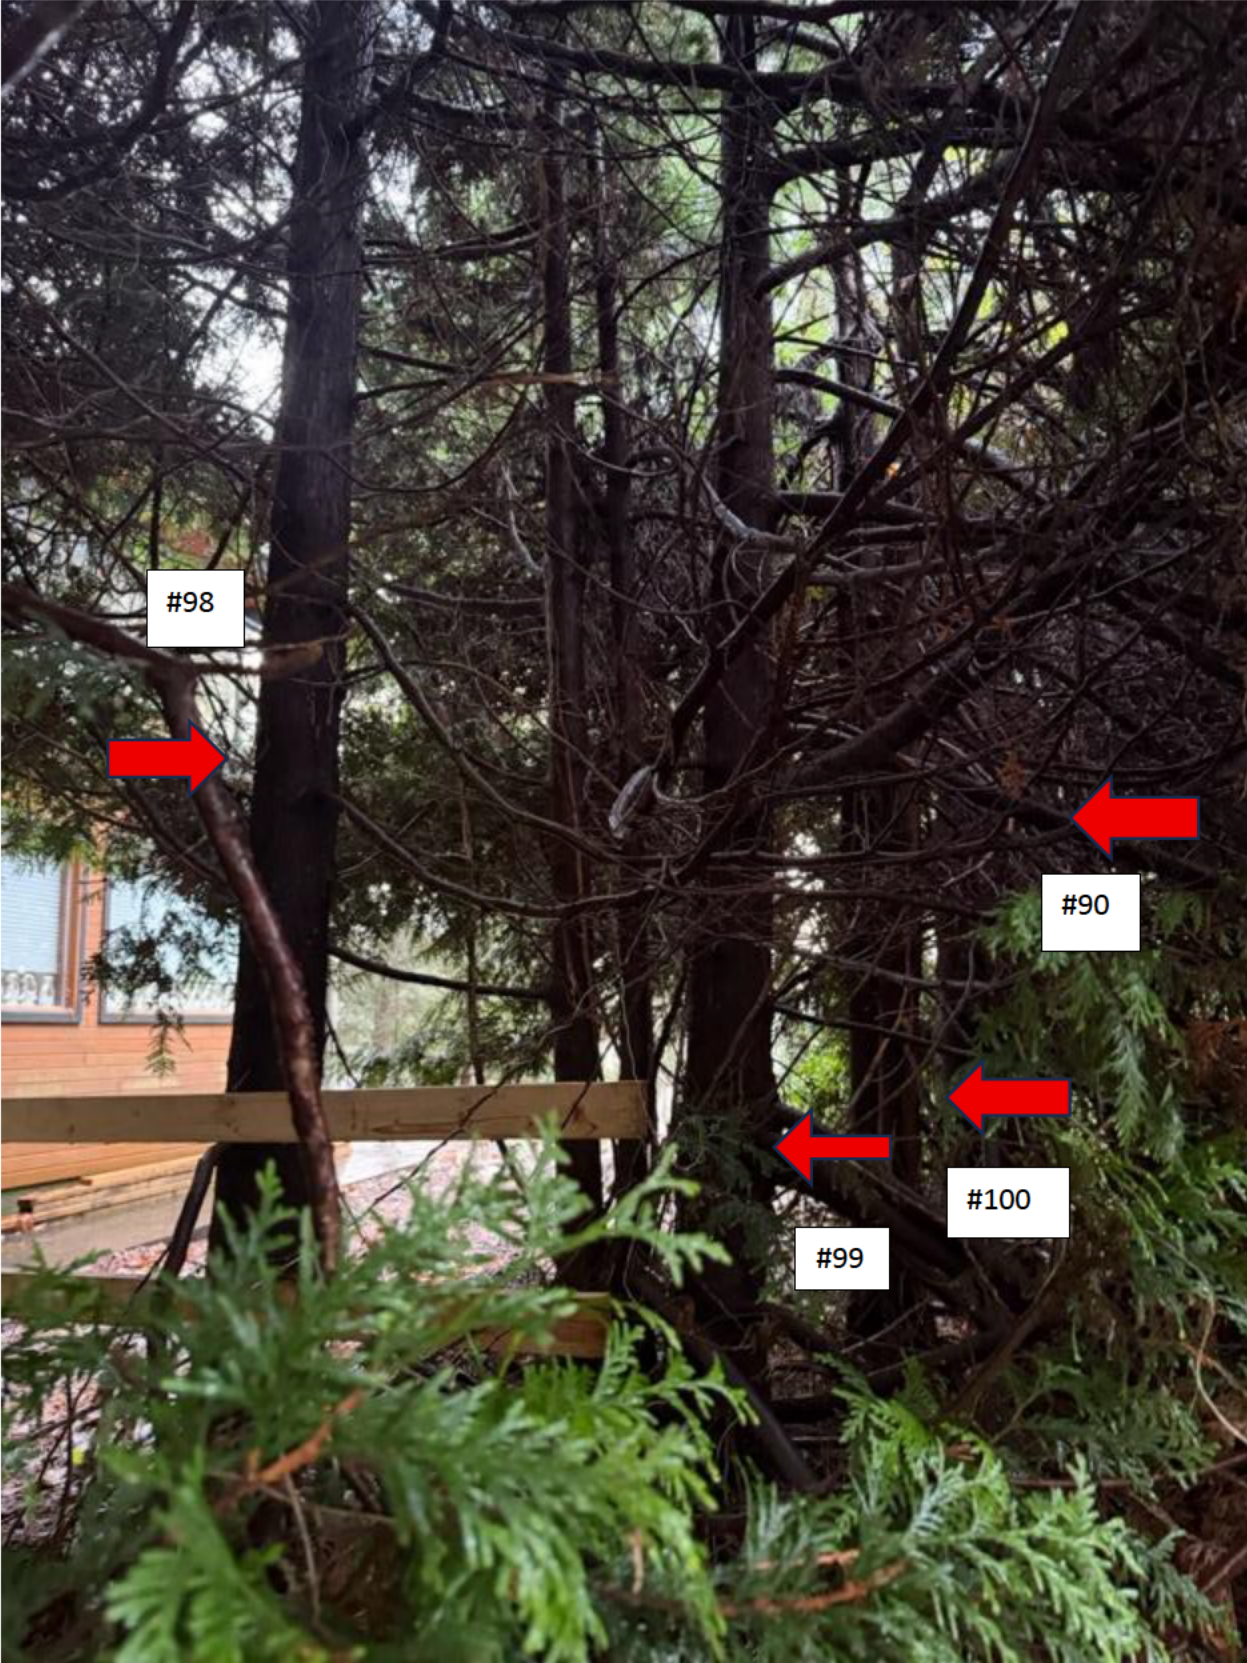
#97

This Western red cedar was previously topped and the foliage sheared with a diameter of less than 20 cm. Condition is poor with 50% dieback. This tree is less dominant with limited access to sunlight. In order for the equipment to access the site, this tree will need to be removed

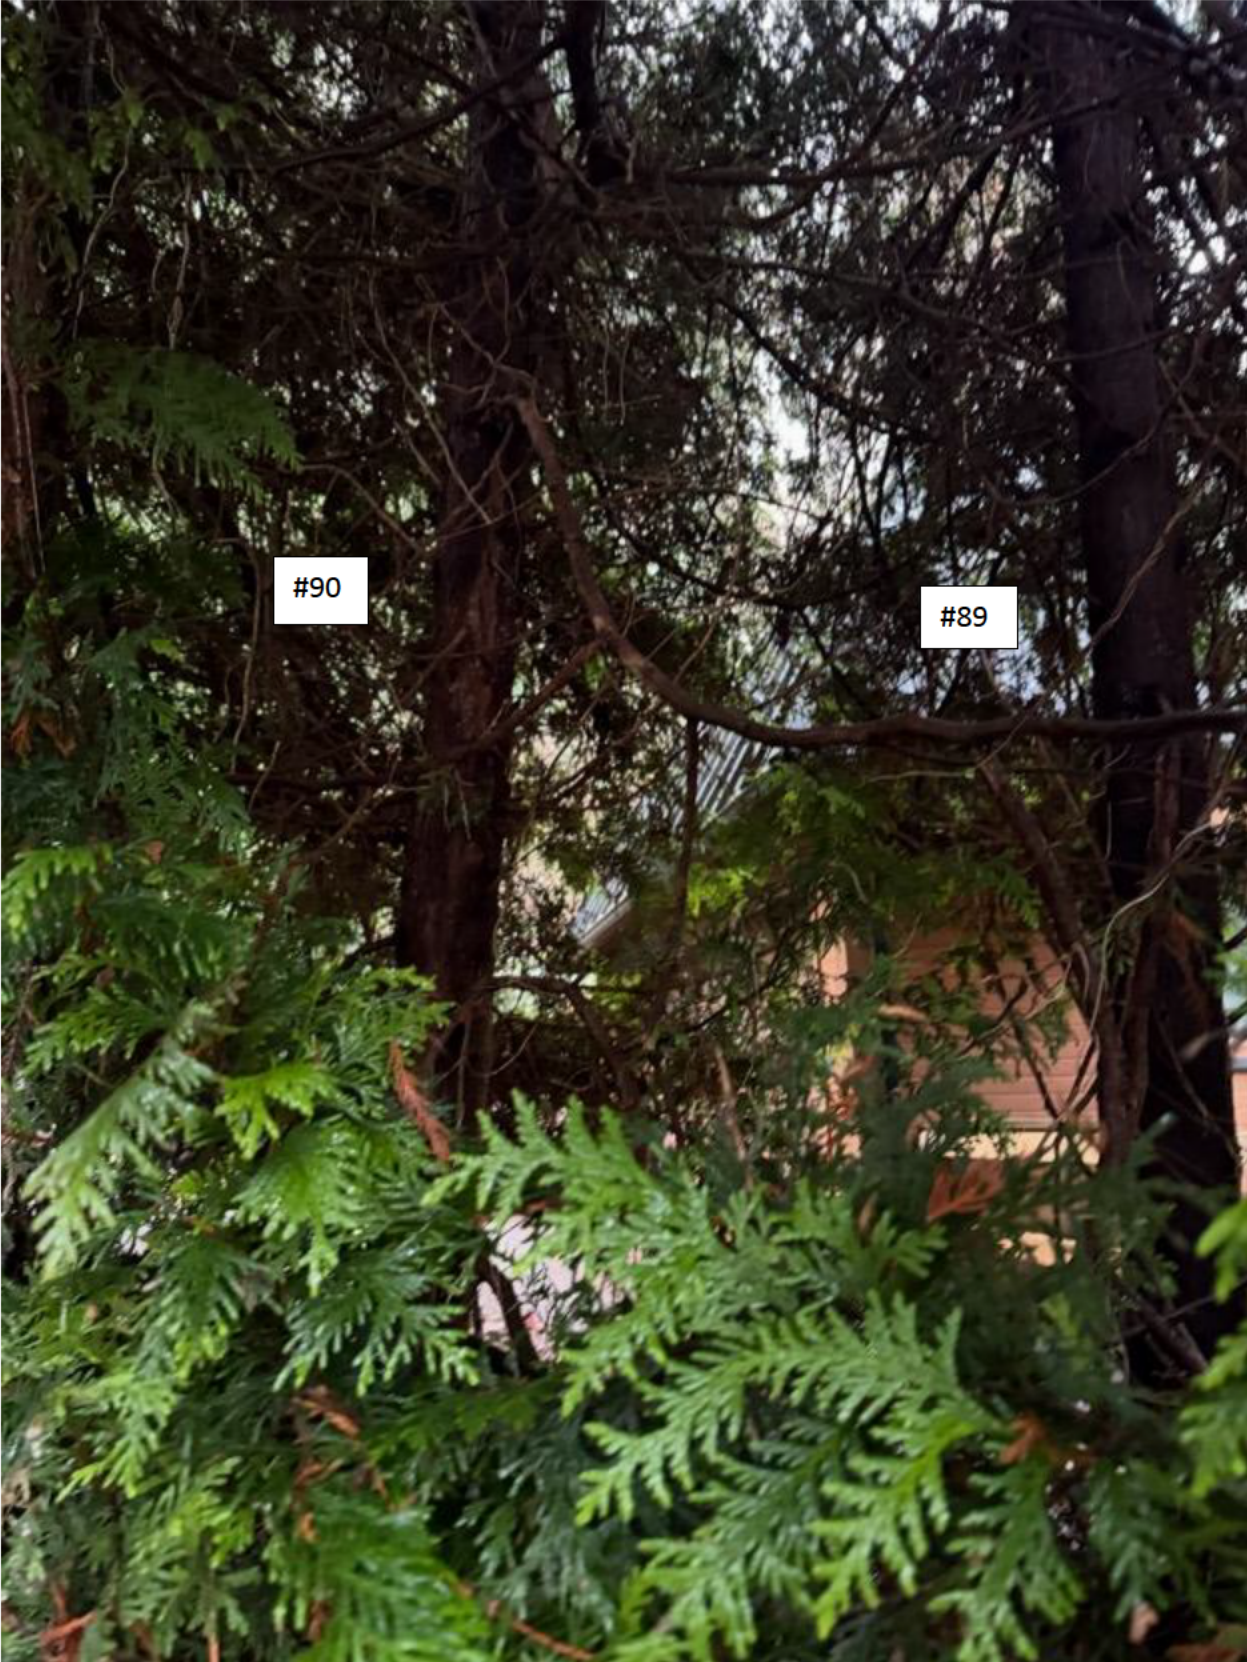
#98

This Western red cedar was previously topped and the foliage sheared with a diameter of less than 20 cm. Condition is poor with 50% dieback. This tree is less dominant with limited access to sunlight. In order for the equipment to access the site, this tree will need to be removed
